## **Water Vole Survey on the River Asker from south of East Bridge Bridport, Dorset.**

**What Three Words locations starting from baseline.bunks.custonian  
Grid ref: SY470927 to commutes.domain.ranch Grid ref SY468926**

**Sunday June 9<sup>th</sup> 2024 1.30pm**

**The Survey was carried out by Emma Bourne and Nicola Dennis at river level.**

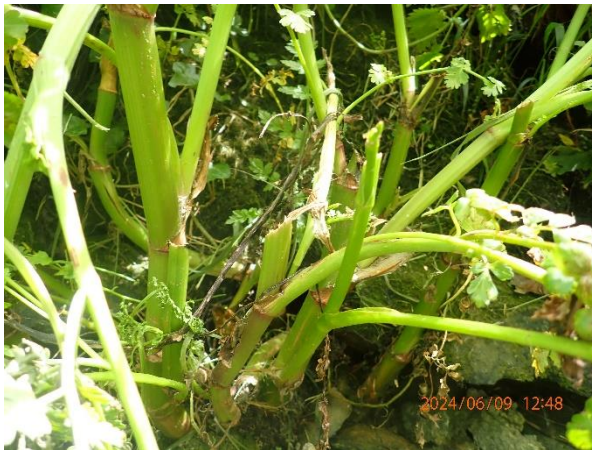
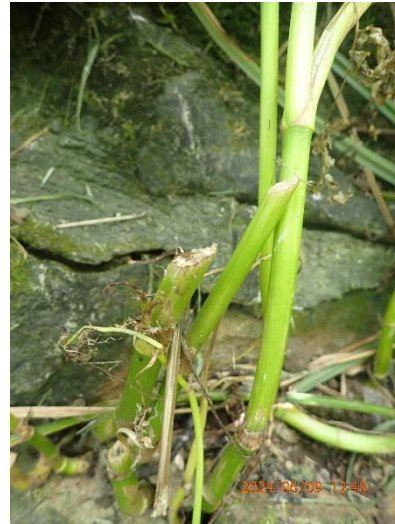
Photos 1&2 vegetation shows signs of typical 45° cut

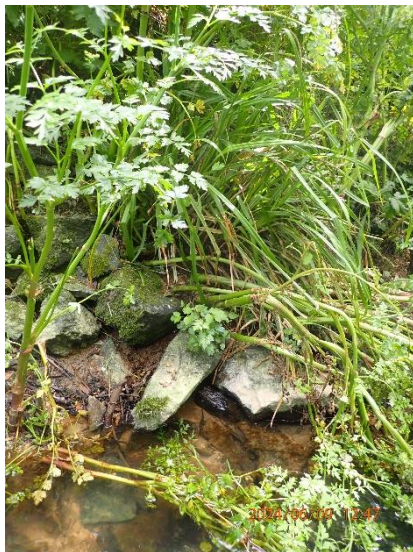
Photo 3 trampled ground leading to a hole between the rocks

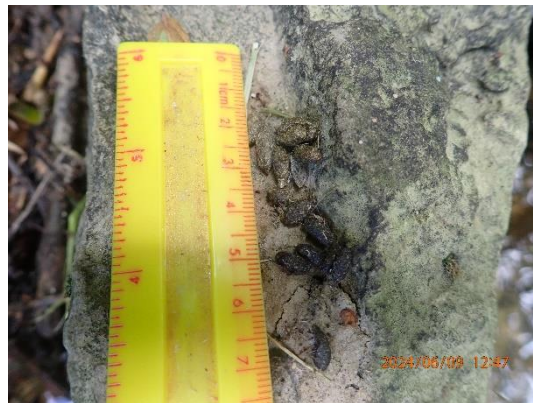
Photo 4 water vole latrine with ruler for scale.

This site had good vegetation level. Water level below 1 metre. Sheltered from fast flow of the weir. Upstream of well used dog entry site.

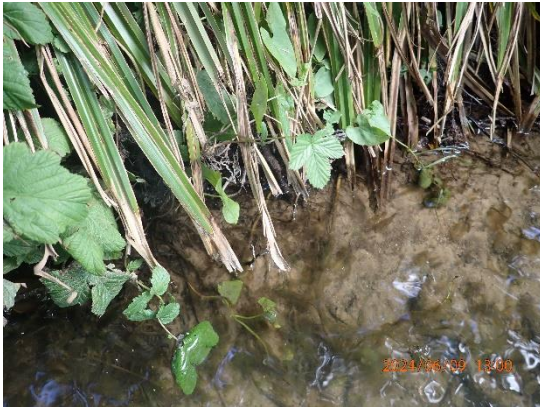
Photo 1 sedge nibbled over time.

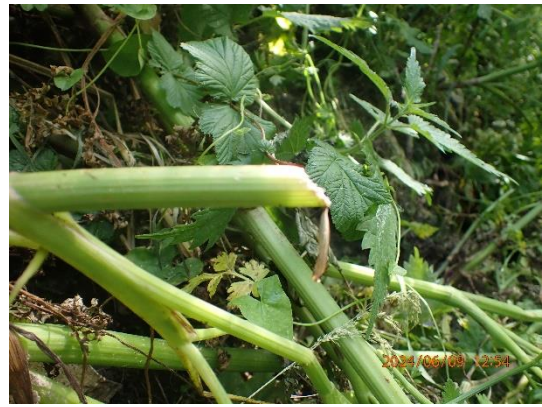
Photo 2 vegetation shows signs of typical 45° cut

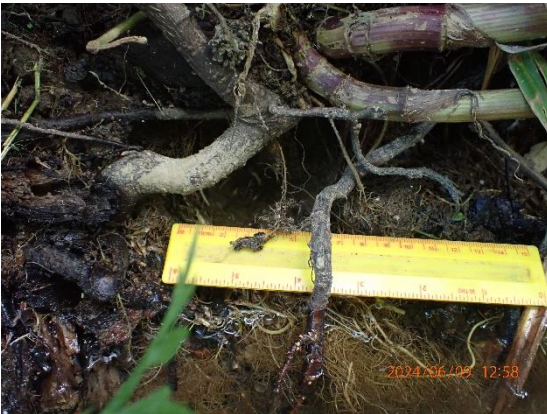
Photo 3 difficult to see but burrow under root system

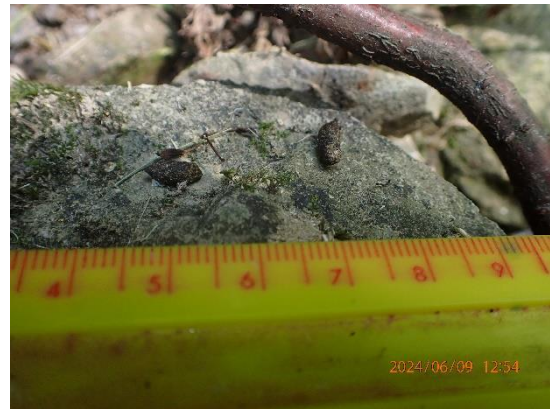
Photo 4 latrine with ruler for scale

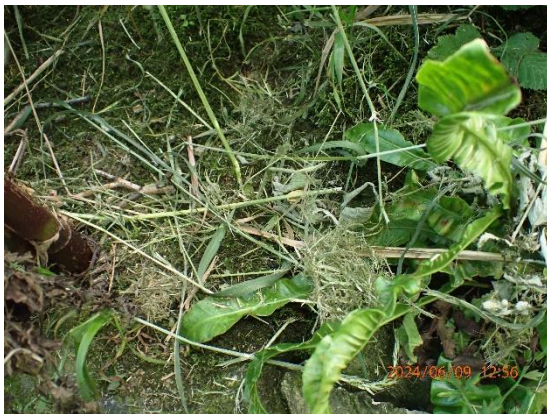
Photo 5 evidence of water vole larder – grasses cut at 45°

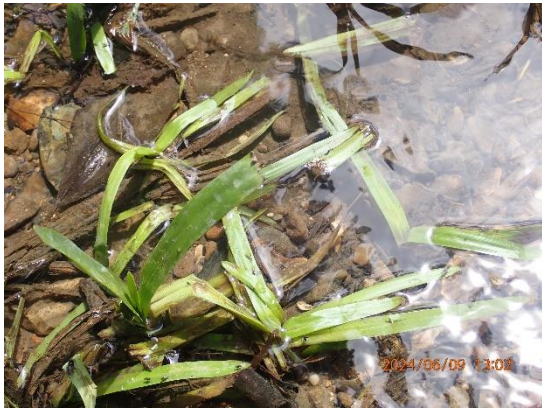
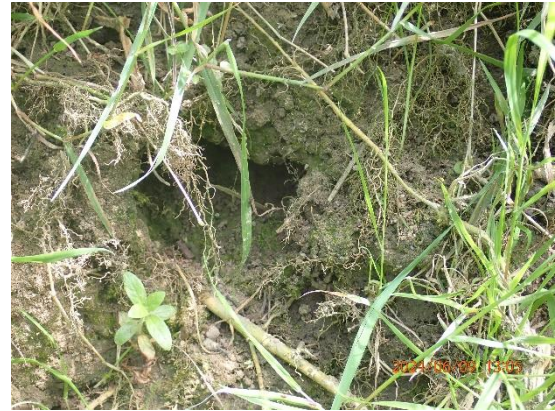
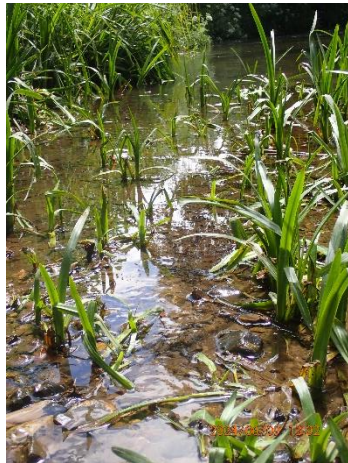
| Deform.morphing.hospitals | SY470927 | Photos 3 | Watervole evidence unsure |

Not sure if this is a current site-  
 Photo 1 shows vegetation nibbled but not at 45°  
 Photo 2 shows suitable size burrow with lawn but no latrine.  
 Photo 3 shows that this area of the river has more vegetation actually in the river on a shingle beach.

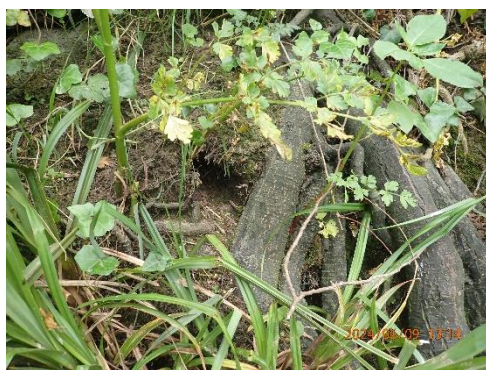
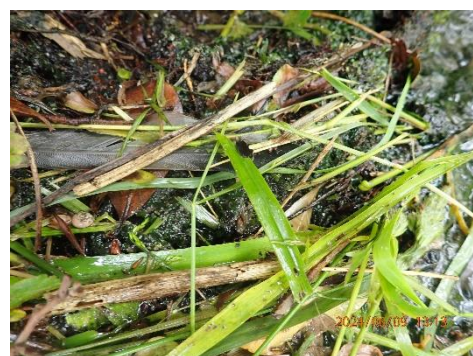
| Soonest.neat.curls | SY470927 | Photos 2 | Watervole evidence unsure |

Photo 1 shows similar hole with lawn to previous site  
 Photo 2 vegetation cut at 45° but unsure if had been washed downstream and deposited on the edge of the river.

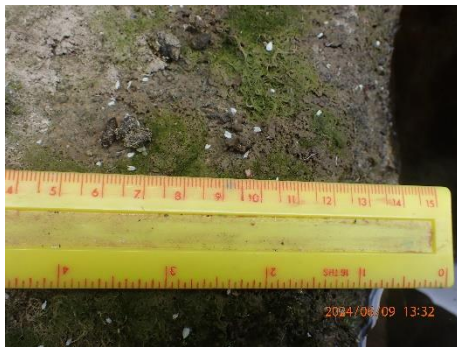
| <b>Glove.stupidly.royally</b> | <b>SY469926</b> | <b>Photos 1</b> | <b>Wolverine evidence present</b> |

Photo 1 latrine showing trampled and solid poo.

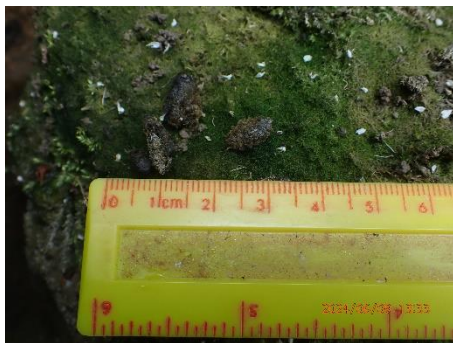
| <b>Seagull.wizard.reset</b> | <b>SY469926</b> | <b>Photos 2</b> | <b>Wolverine evidence present</b> |

Photo 1 latrine with ruler for scale

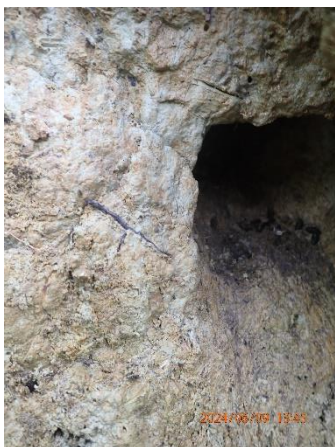
| <b>Rocked.surreal.bolsters</b> | <b>SY469926</b> | <b>Photos</b> | <b>Wolverine evidence present</b> |

Photo 1 bankside burrow with latrine

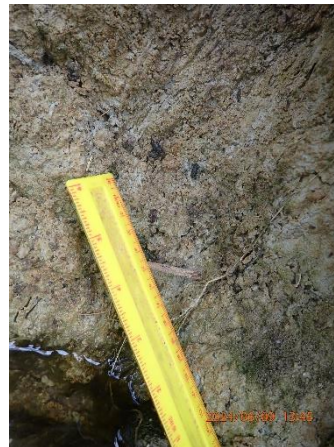
Photo 2 latrine sliding down the bank

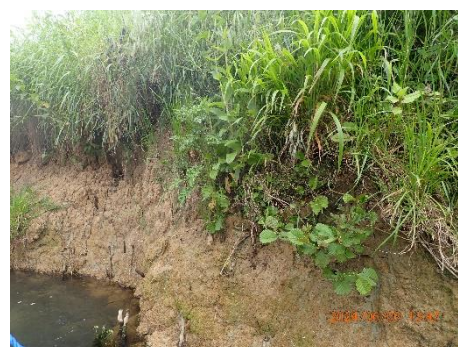
Photo 4 shows considerable bank erosion no vegetation for first 1 metre upwards from water level.

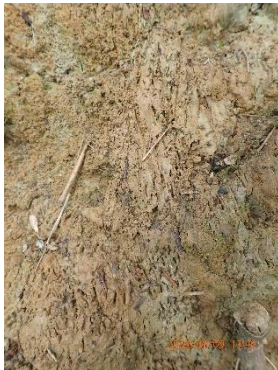
| <b>Fidgeting.comb.scooters</b> | <b>SY469926</b> | <b>Photos</b> | <b>Wolverine evidence present</b> |

Photo 1 scrabbling marks up the eroded bank

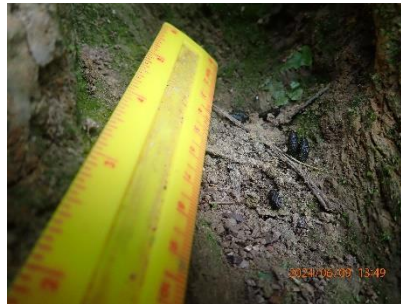
Photo 2 latrine right at the base of the bank near root system

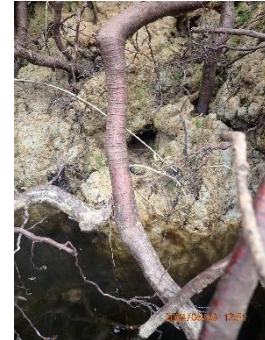
Photo 3 burrow in behind exposed root system

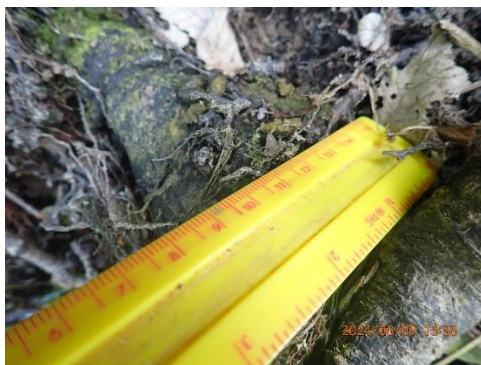
| <b>Pleaser.dices.vitals</b> | <b>SY469926</b> | <b>Photos</b> | <b>Wolverine evidence present</b> |

Photo 1 latrine with ruler for scale

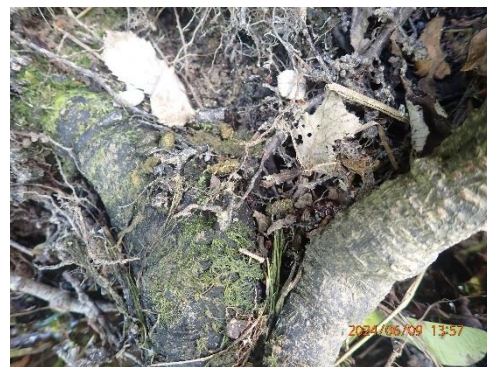
Photo 2 same latrine showing variation of colour to previous latrines upstream.

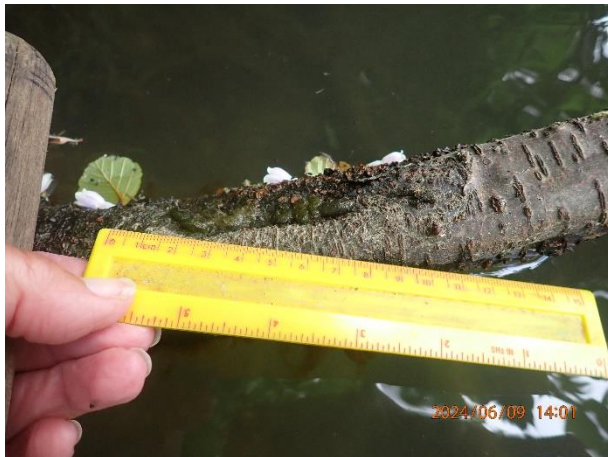
| Not taken | SY469926 | Photos 2 | Wolverine evidence present |

Photo 1 latrine on semi-submerged branch

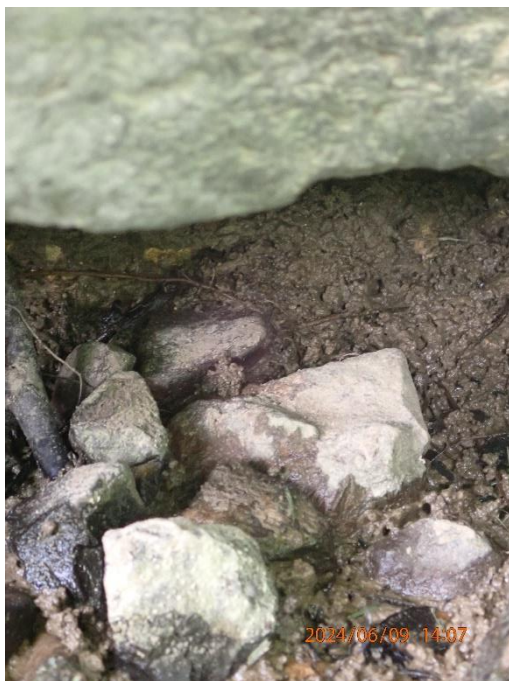
| Intruders.finishers.horn | SY469926 | Photos 2 | Wolverine evidence present |

Pic 1 – obvious earth movement under stones but could be rats

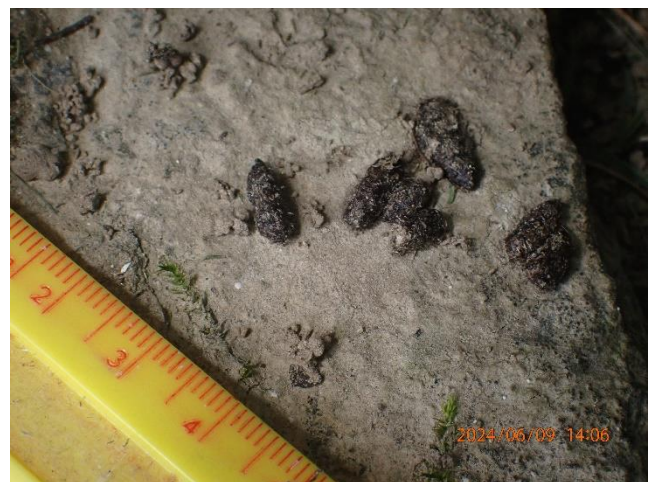
Pic 2 – latrine with ruler for scale

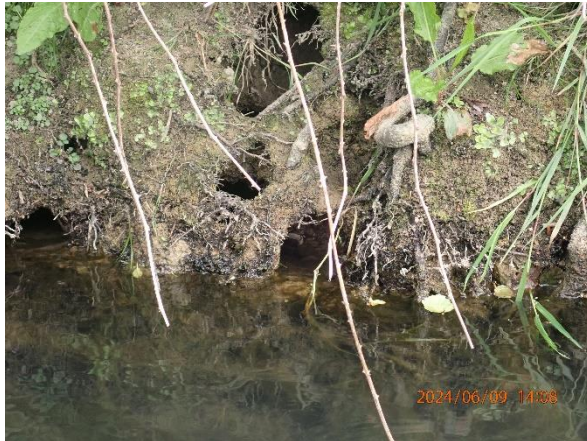
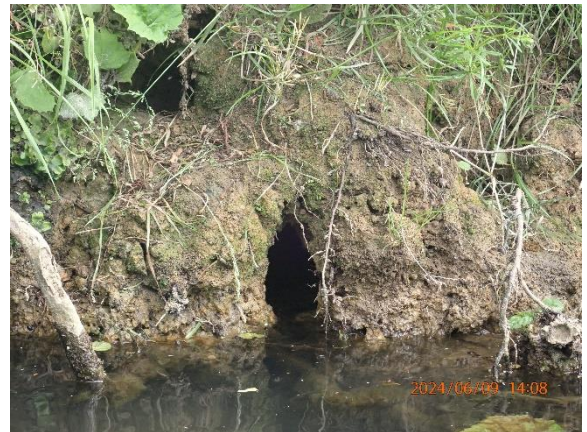
| Not taken | SY469926 | Photos 4 | Wolverine evidence present |

Photos 1&2 series of burrows with surrounding lawn.

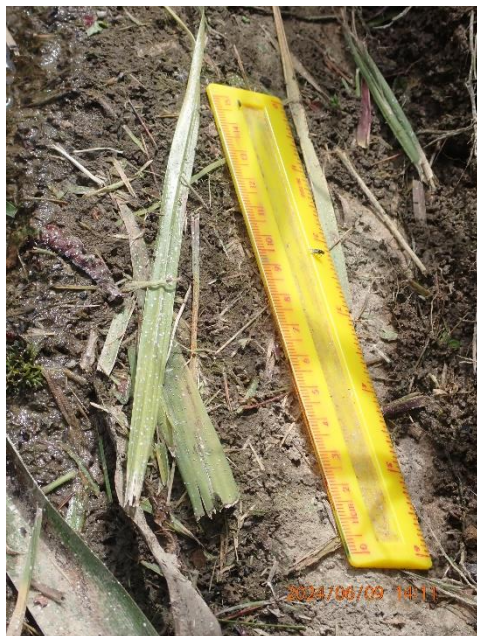
Photo 3 larger store with ruler for scale of pieces cut.

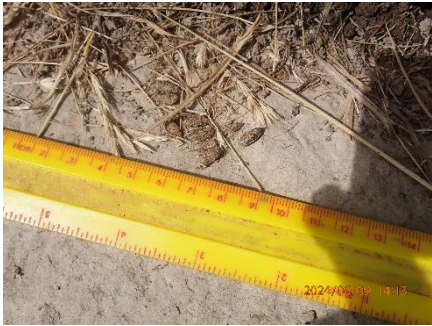
| Beauty.says.solve | SY469926 | Photos 3 | Watervole evidence present |

Photo 1 Latrine with ruler for scale

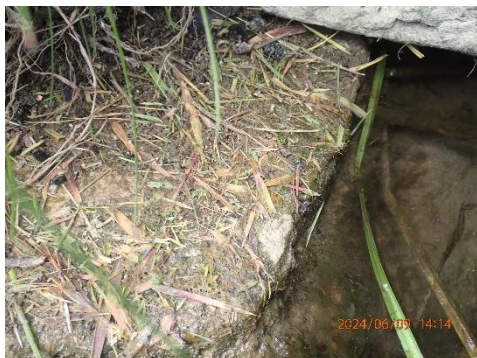
| Subject.toasters.dancer | SY468926 | Photos 3 | Watervole evidence present |

Photo 1 Latrine and possible remains of food store

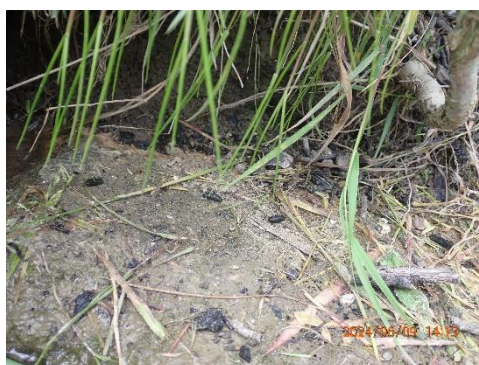
Photo 2 Latrine

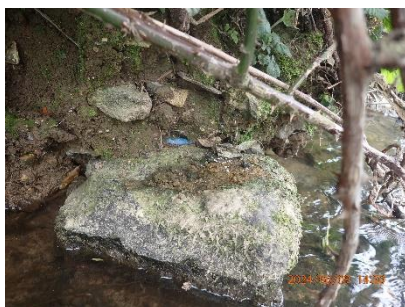
| Expand.hence.declines | SY468926 | Photos | Watervole evidence present |

Photo1 Latrine with trodden poo

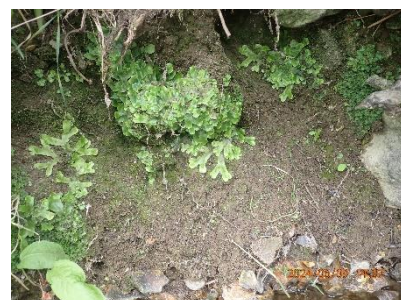
Photo 2 Clear path from water to burrow

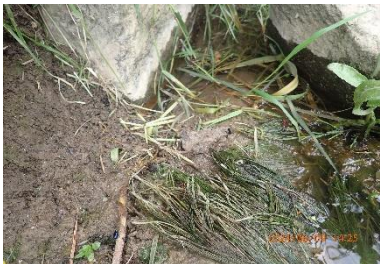
Photo 2 Food larder

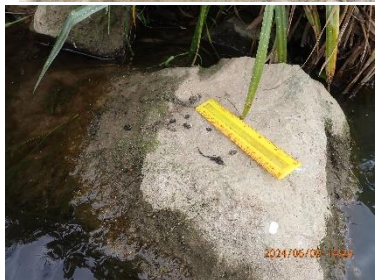
Photo 4 Trampled ground and possible food store

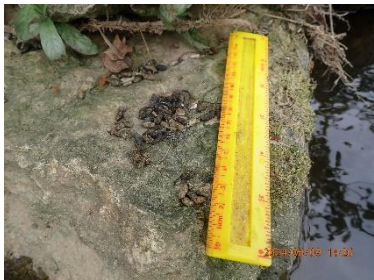
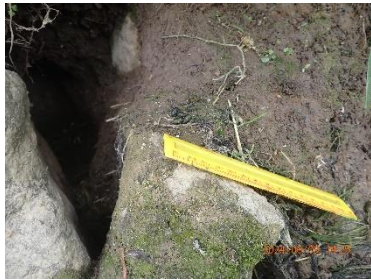
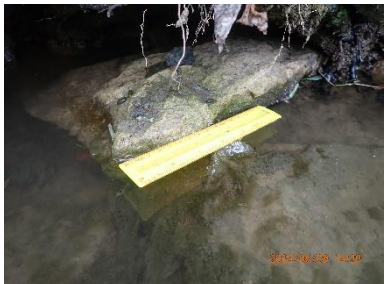
Photo 5 6&7 Latrines, some trampled and well used some almost solitary.

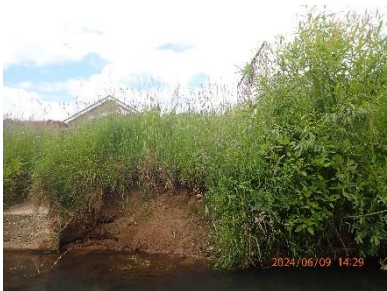
Photo 8 Burrow next to well worn area.

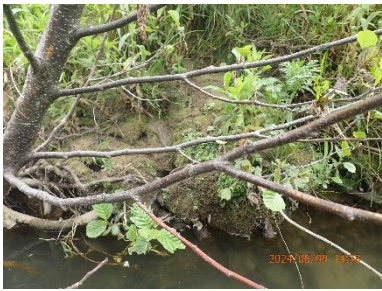
Photo 9 Latrine

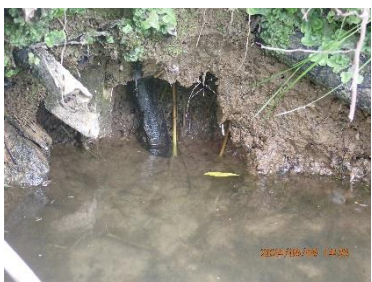
Photo 10 shows area in this location that has lost 6 ft of bank over the winter leaving no vegetation on vertical bank.

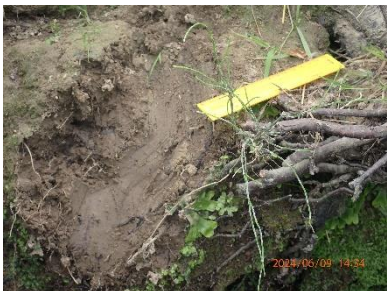
Photo 11 Burrow and well worn area opposite 16 Folly Mill Gardens

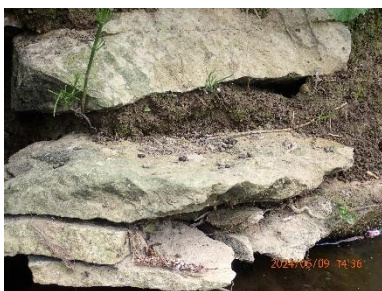
Photo 12 Water level burrow showing cut vegetation in the entrance. Water vole has been seen carrying vegetation to this burrow and disappearing inside.
